**BorgWarner**

**Kysor On/Off Diagnostic Guide**

# Kysor Rear Air Fan Clutch Diagnostics

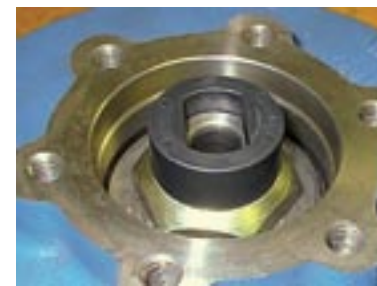
Figure 1 Pulley hub with coupler in place on shaft

The coupler is located between the rear of the fan clutch and the pulley hub center shaft. It is made of semi-hard black plastic, 1<sup>3</sup>/<sub>8</sub>" diameter x 5/8" thick, with a flat sided hole through the center. (Figure 1)

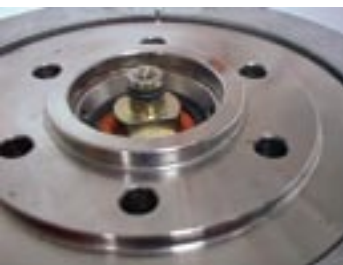
There is no load on the coupler during clutch operation. The coupler simply keeps the clutch piston rod (center shaft) from turning. It couples the piston rod to the shaft of the pulley hub by engaging both the flats of piston rod and the pulley hub shaft. The O-ring on the rear of the piston rod is the air seal between the clutch and pulley hub. (Figure 2)

Figure 2 Clutch with rear O-ring on piston rod

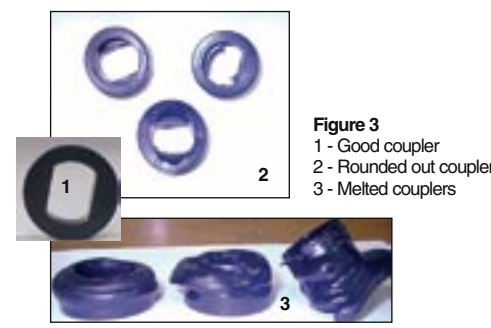
Rounded out damage to the coupler and rear O-ring failure can occur when the clutch piston rod is forced to rotate. (Figure 3-2) This can be caused by a clutch bearing failure or improper clutch servicing. The clutch cylinder cap must be held stationary by hand when removing the front retainer nut.

Figure 3  
1 - Good coupler  
2 - Rounded out coupler  
3 - Melted couplers

If the coupler is rounded out, the clutch ball bearings need to be inspected carefully. The clutch should be replaced if bearings are damaged or worn.

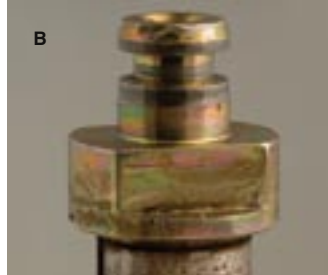
Damage to the rear of the piston rod (center shaft) and rear O-ring is usually caused by worn or damaged pulley hub bearings. This may first be noticed as an air leak at the rear of the clutch.

The rear portion of the piston rod enters into the front of the pulley hub shaft. Bearing wear or damage in the pulley hub may cause the pulley to not run true on the shaft. Bearing wear can cause damage to the rear O-ring and eventually the piston rod. (Figure 6) There should be no play in the pulley hub bearings. Check for scuffed plating on the piston rod around the O-ring area. Check for worn metal at the rear of the piston rod. If the metal is not damaged, the clutch can be reused.

Figure 6 O-ring area of new piston rod (Figure A), minor damage at rear of piston rod showing scuffed plating serviceable with repair kit (Figure B), and severe damage to rear of piston rod showing worn-away metal, not serviceable. (Figure C)

Always determine and correct the cause of failure. Inspect and make any pulley hub repairs or replace the pulley hub as required if worn or damaged. Pulley hub bearing kits are available for service.
